# Manhole Inspection Summary

Manhole # S71S\_\_009MH

Insp Date: **4/17/08 1:55 AM**

**Location** Address: **6709 Dundalk Ave.**

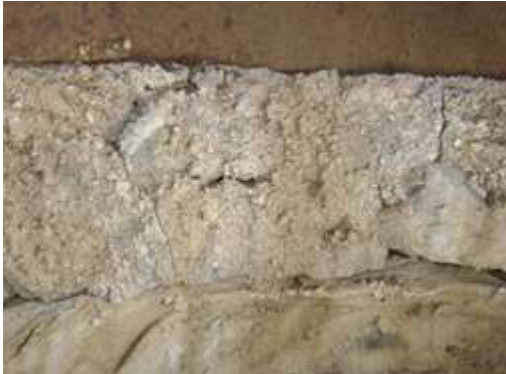
Defect 2

Condition: ☐ Sound ☐ Cracked ☐ Root Intrusion ☒ **Loose Brick** ☒ **Deteriorated**

Infiltration: ☐ None ☒ **Joint** ☐ Cracks ☐ Mortar ☐ Roots ☐ Wall

cracks in mortar at frame adjustment

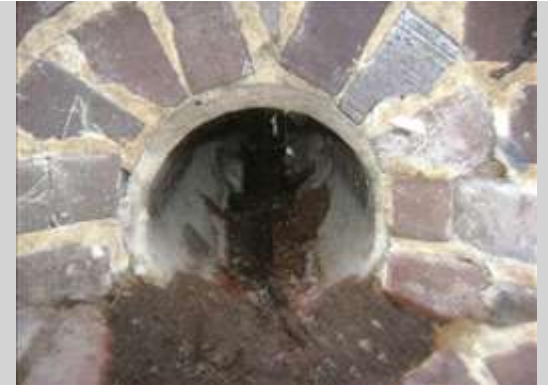
12 O'Clock Outflow

Deposits: ☐ None ☒ **Mud** ☐ Sludge ☐ Debris ☐ Grease

Silt Depth: **0.5** (in.) Deposits Extent: **Light**
